Tune Up System on Toyota 4k Series Engines

In this study, the object of the research is the Toyota Kijang Doyok Generation II 4K Engine Series which came out in 1981. The car underwent periodic repairs or Tune Up because the engine had been operating for a long time so that all its components were not in their standard condition. If you look at it, the engine oil is diluted and pitch black, the fan strap is cracked and broken because it is not

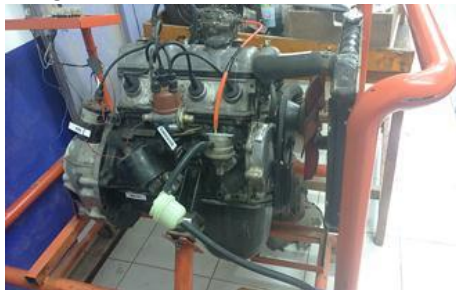
The engine has also undergone changes so that the deer are more powerful. At the beginning of its appearance, this car was equipped with the same 4k engine as the Toyota Corolla DX engine. The Toyota 4k engine has a capacity of 1290 cc (1300cc) which still uses an OHV (Overhead Valve) pushrod. This 4k engine is able to produce 74 hp at 5600 rpm and 105 Nm of torque at 3600 rpm.

Figure 3.3. Toyota Kijang 4k Series Engine
